# **Growth of Laser-Induced Damage During Repetitive Illumination of HfO<sub>2</sub>-SiO<sub>2</sub> Multilayer Mirror and Polarizer Coatings**

**F. Y. Génin  
C. J. Stolz  
M. R. Kozlowski**

**This paper was prepared for submittal to the  
28th Annual Symposium on Optical Materials  
for High Power Lasers  
Boulder, Colorado  
October 7-9, 1996**

**January 24, 1997**

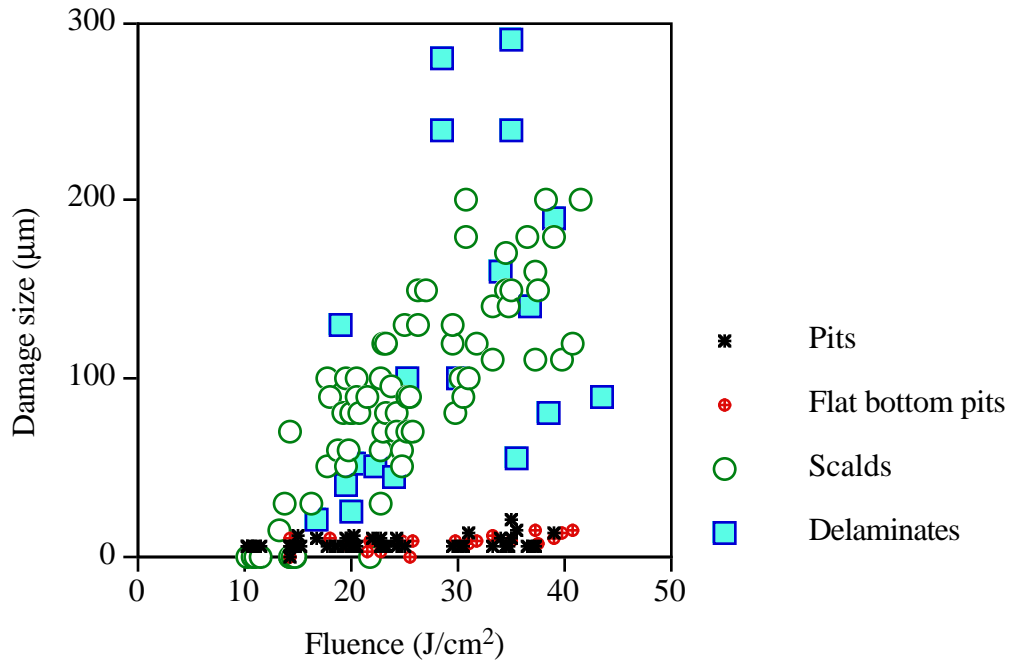
**Fig. 1:** Damage size of the pit, flat bottom pit, scald, and delaminate morphologies as a function of fluence after a single shot (from ref. 27). The measurements for the mirrors and polarizers of various origins (i.e. OCLI, S-P, LLNL) tested at 45° and 56° are plotted on this graph.

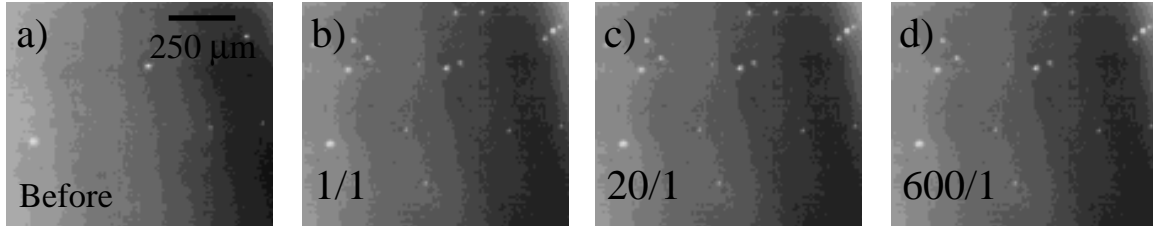
Pits formation usually occurs during the initial shot by ejection of nodular defects.<sup>30,31</sup> The damage tests on the reflective optics showed that the pit morphology does not tend to grow during repetitive illumination (see Figs. 2 and 3). The pit size does not usually exceed 40 μm. Although it is difficult to quantify exactly the increase of pit size with fluence because of the lack of resolution with the optical microscope, pits were generally found to be smaller when the samples are initially irradiated at fluences below 15 J/cm². This agrees with previous experimental studies reporting that initial low fluence illumination or laser conditioning can improve the damage threshold.<sup>32,33</sup> This study also suggests that from a functional damage improvement standpoint, multiple step conditioning could be replaced by a single step conditioning process.

**Fig. 2:** Back light optical micrographs of pits a) before, after b) 1, c) 20 and d) 600 shots at 1064 nm on a mirror at  $40 \text{ J/cm}^2$  at  $45^\circ$ , in p-polarization.

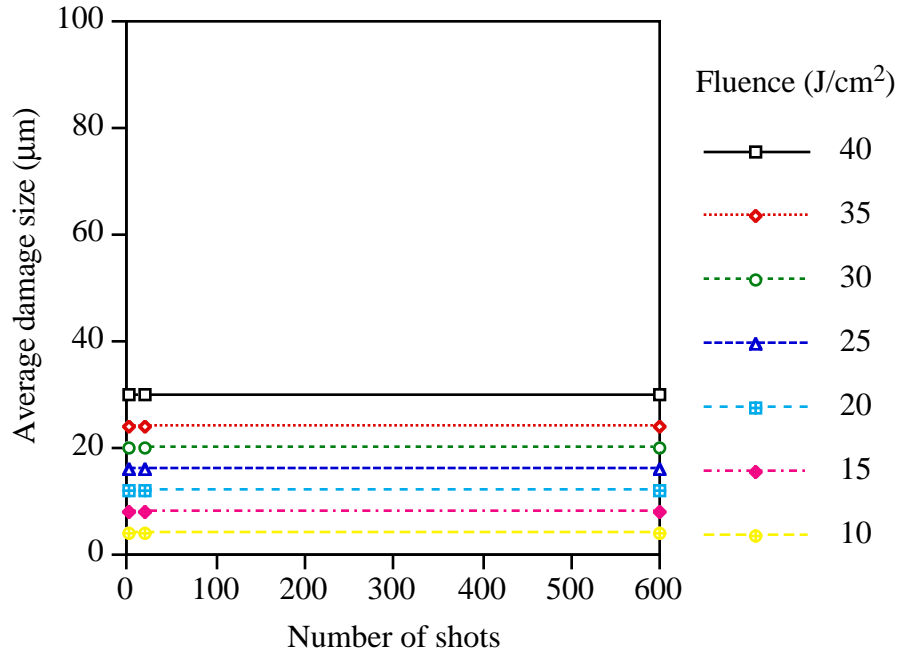
**Fig. 3:** Average pit size as a function of number of shots at 1064 nm in  $45^\circ$  mirrors tested in p-polarization at fluences ranging from 10 to  $40 \text{ J/cm}^2$ .

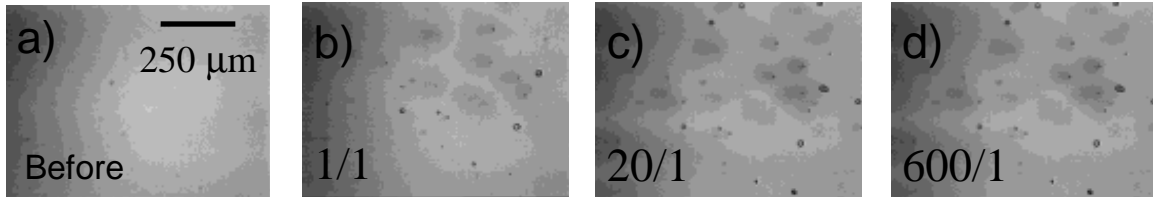
Flat bottom pits were occasionally found in some of the optics studied. SEM characterization of this type of damage showed that the top layer can fail at the hafnia-silica interface.<sup>34</sup> Figures 4 and 5 show the typical damage growth behaviors of flat bottom pits at 31 and  $44 \text{ J/cm}^2$  in a high reflector coating. The damage size after one shot increases with fluence. Such damage does not grow at low fluences but can become unstable above a critical fluence (see Fig. 6). It is possible that damage growth depends on the initial size of the pit; this effect was not investigated in this study.

**Fig. 4:** Nomarski optical micrographs of an irradiated site a) before, and after b) 1, c) 20 and d) 600 shots at 1064 nm on a mirror. The flat bottom pits shown here were formed at  $31 \text{ J/cm}^2$  at  $45^\circ$ , in p-polarization and did not grow.

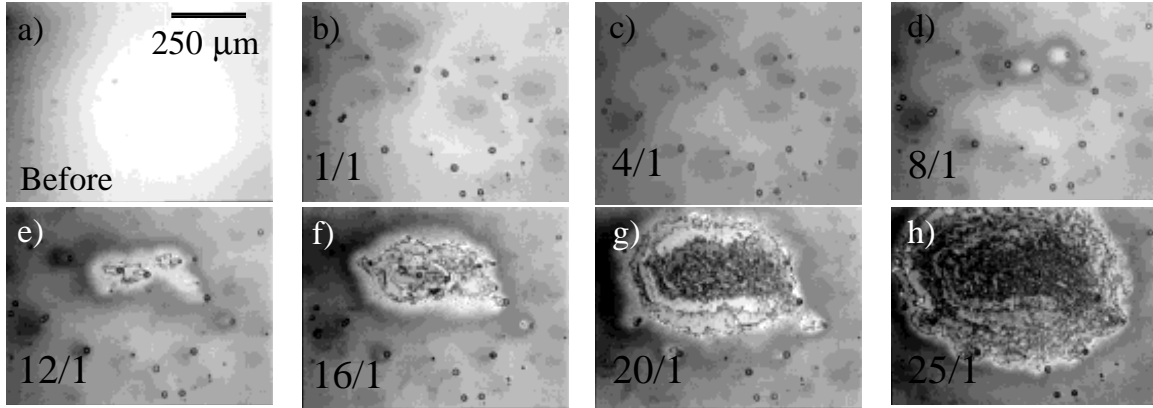
**Fig. 5:** Nomarski optical micrographs of an irradiated site a) before, and after b) 1, c) 4, d) 8, e) 12, f) 16, g) 20 and h) 25 shots at 1064 nm on the same mirror as Fig. 4. The flat bottom pits shown here were formed at 44 J/cm<sup>2</sup> at 45°, in p-polarization and grew catastrophically.

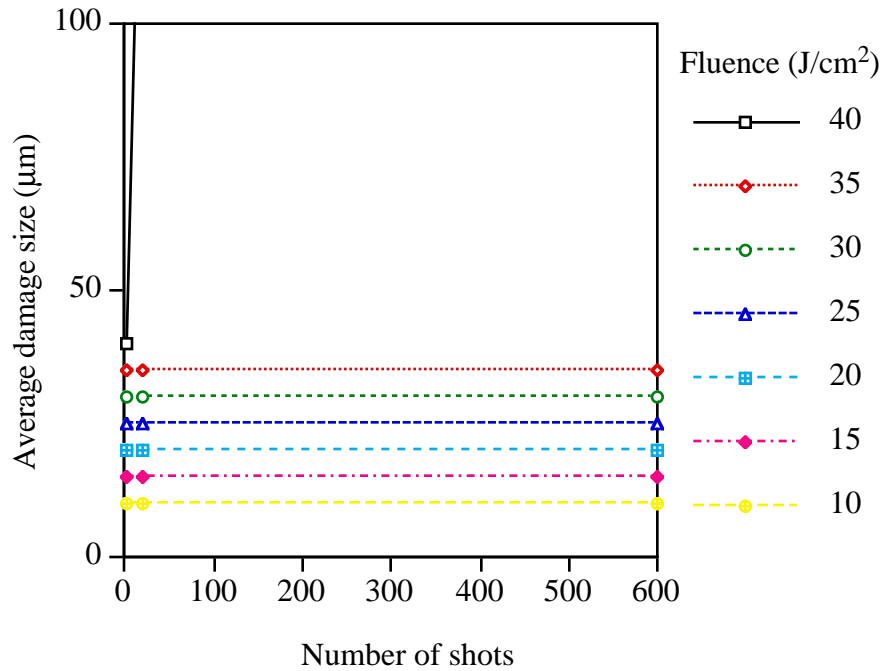
**Fig. 6:** Average flat bottom pit size as a function of number of shots at 1064 nm in 45° mirrors tested in p-polarization at fluences ranging from 10 to 40 J/cm<sup>2</sup>.

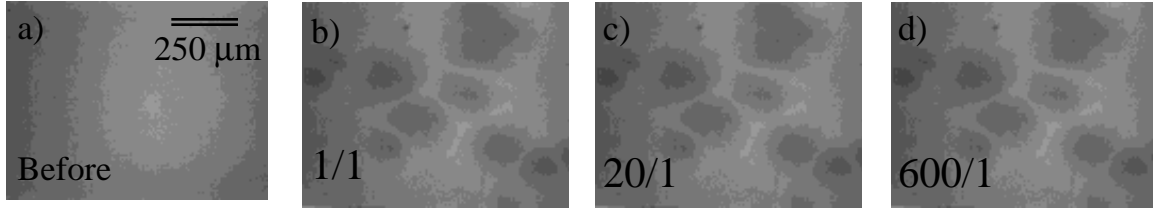
Scalds were typically found at fluences above 13 J/cm<sup>2</sup>. Their size increased almost linearly with fluence. It is believed that scalds result from plasmas that ignite at nodular defects or contamination particles and scorch the silica surface. The earlier study of the 1-on-1 damage morphologies<sup>27</sup> showed that such damage can only produce very small phase modulations and therefore do not affect the functional damage threshold of the high reflectors. The scalds are formed on the first shot and do not grow further even at high fluences (see Figs. 7 and 8). Their size increases with pulse length and fluence.

**Fig. 7:** Nomarski optical micrographs of an irradiated site a) before, and after b) 1, c) 20 and d) 600 shots at 1064 nm on a mirror. The scalds shown here formed on the first shot at 41 J/cm<sup>2</sup> at 45°, in p-polarization and did not grow.

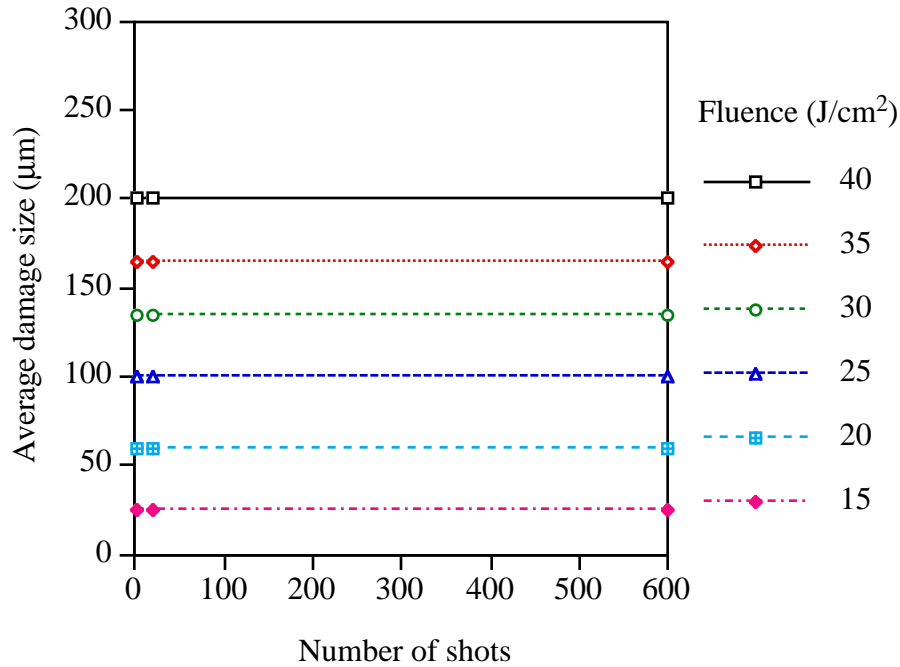
**Fig. 8:** Average scald size as a function of number of shots at 1064 nm in 45° mirrors tested in p-polarization at fluences ranging from 15 to 40 J/cm<sup>2</sup>.

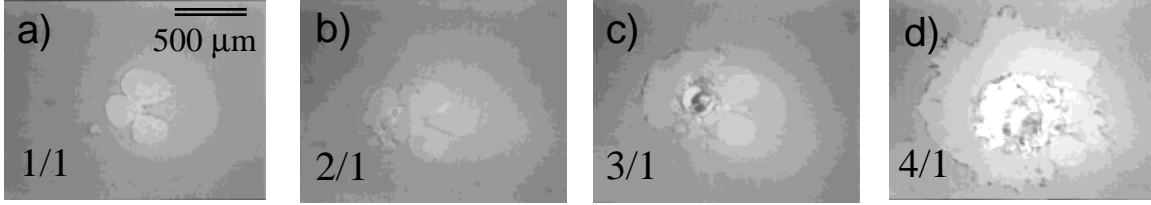
Delaminates (i.e. delamination of the outer layer) have characteristics that are similar to scalds; they seem to occur as a result of plasma ignition and the size vs. fluence relationship is very similar to that of scalds. Delaminates can very quickly grow to catastrophic proportions (see Figs. 9 and 10). They represent the type of damage that most limits the functional threshold of the high reflectors, and particularly polarizers.<sup>25,27</sup>

**Fig. 9:** Nomarski optical micrographs of delaminates after a) 1, b) 2, c) 3, and d) 4 shots at 1064 nm on a polarizer. The damage grew very rapidly to catastrophic proportions only after 4 shots at  $46 \text{ J/cm}^2$  at  $54^\circ$ , in s-polarization.

The recent development effort of NIF polarizers focused on eliminating the cause of delamination. Other research conducted in parallel with this study also showed that the electric field distribution in the multilayer stack (which can vary with thin film design or beam incidence angle) can strongly influence the damage morphology. Such effects are reported elsewhere in these proceedings.<sup>25,35</sup>

morphology was found to be sensitive to the thickness of the silica overlayer. Their occurrence was prevented by increasing the thickness of the overlayer.

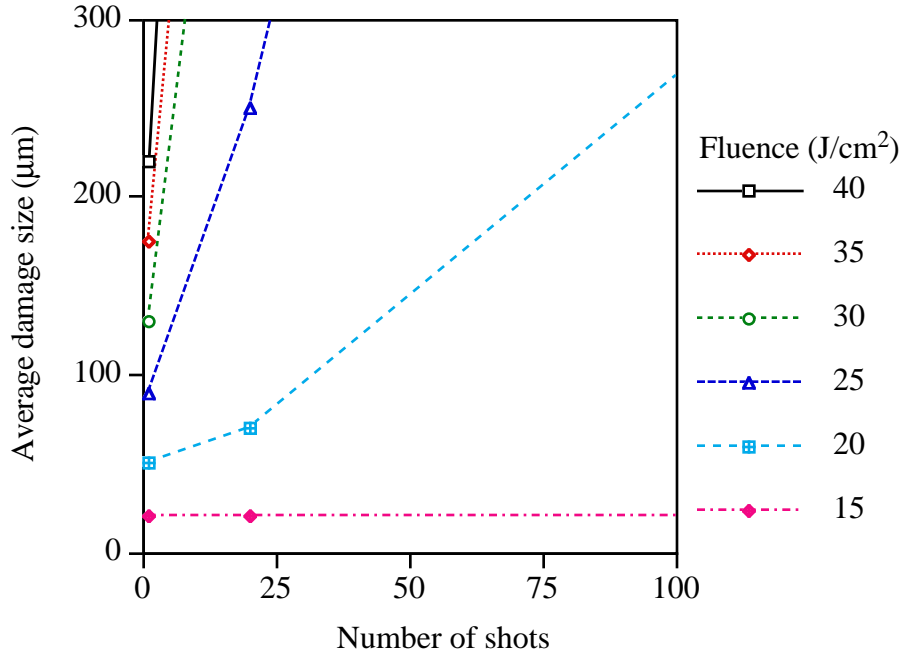
**Fig. 10:** Average delaminate size as a function of number of shots at 1064 nm in  $56^\circ$  polarizers tested in s-polarization at fluences ranging from 15 to  $40 \text{ J/cm}^2$ .
